**LAND SUBSIDENCE AND PROBLEMS
AFFECTING LAND USE AT
EDWARDS AIR FORCE BASE
AND VICINITY, CALIFORNIA,
1990**

**U. S. GEOLOGICAL SURVEY
Water-Resources Investigations
Report 92-4035**

**Prepared in cooperation with the
U.S. DEPARTMENT OF THE AIR FORCE**

Water-Resources Investigations Report 92-4035

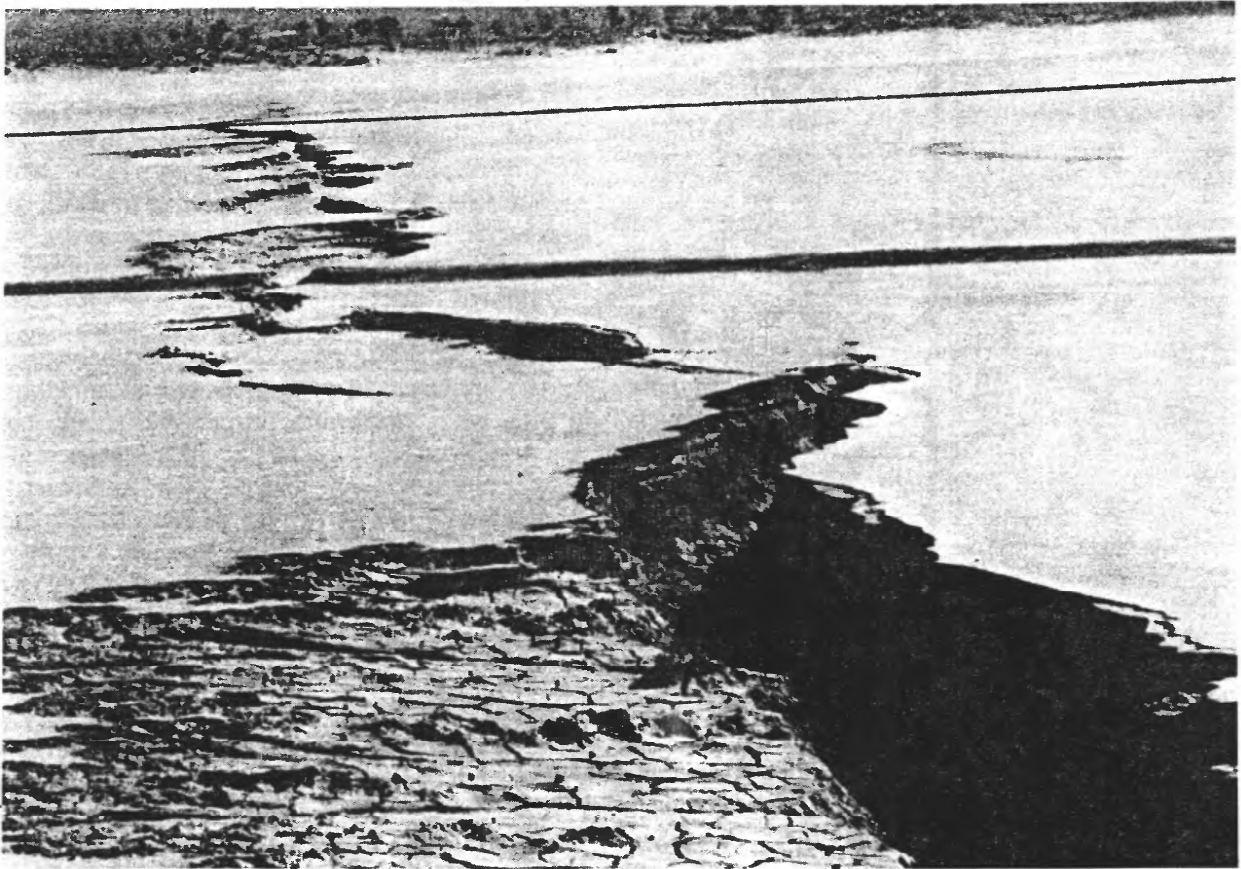
Figure 2. Fissure across Runway 25 on Rogers lakebed after January 1991 flooding. This fissure also is a drainage channel and point of infiltration to ground water. Note cracks that form small polygons on eroded area near fissure. Width of fissure at land surface is as much as 10 feet. Photograph courtesy of U.S. Air Force, February 1991.

Expenditures to date (1990) for runway repair have been high, and the repairs have been somewhat ineffective (Melvin Marmet, U.S. Air Force, oral commun., July 1991). The load-carrying capacity of the repaired lakebed is less than that of the original lakebed, and active deformation continues to adversely affect the repairs. Evidence of new sinklike depressions and fissures indicates that the lakebed is being subjected to continuing land-surface deformation.

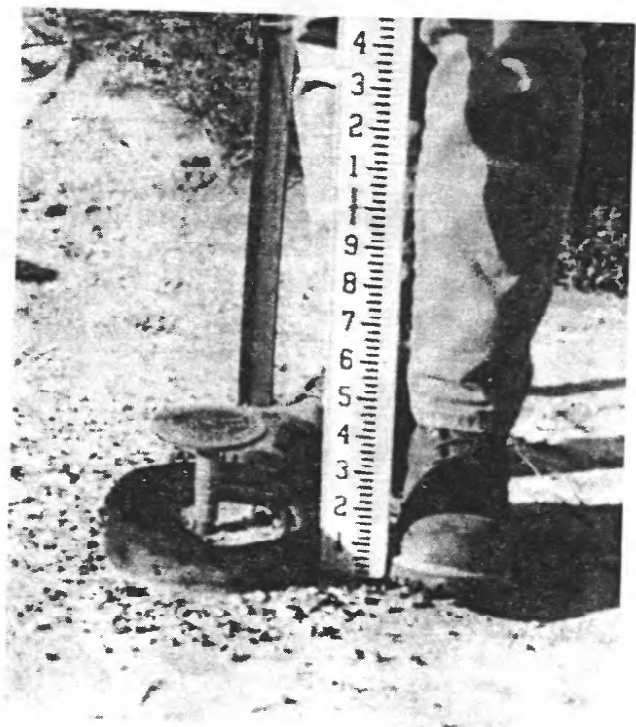
Figure 8. Bench mark 33MDC showing near-surface land subsidence that has caused exposure of the bench-mark stem. Bench mark, located east of Rogers Lake near Mercury Boulevard, was installed in 1973. Photographed April 1990.

Bench mark 33MDC (figs. 5 and 8), on the east side of Rogers Lake, shows an interesting subsidence phenomenon. When this bench mark was established in 1973, the brass cap and the top of the 6-inch diameter pipe were placed flush with the land surface. The brass cap presently is about 0.3 ft above the 6-inch diameter pipe, which is about 0.1 ft above the land surface. Wind erosion of the soil probably caused the 0.1 ft exposure of the 6-inch diameter

pipe. The brass cap is 0.3 ft lower in elevation than in 1973 on the basis of elevations determined from the regional vertical-control network surveyed in 1989-91 (table 1). The depth of the pipestem that supports the brass cap is unknown, but it is likely to be less than 20 ft. Therefore, there may be both shallow (depths less than 20 ft) and deep (depths greater than 20 ft) subsidence occurring at this site.

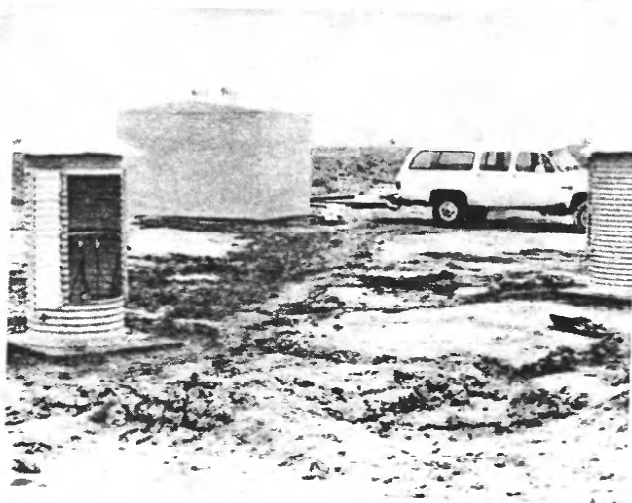
Figure 9. Holly extensometer site, looking east. Extensometer is in large building in center. Observation wells are in small, round buildings. Land-surface elevation is 2,302 feet. Photographed August 1990.

In May 1990, an extensometer was installed at the Holly well site (fig. 9) to measure the amount and rate of land subsidence near the South Track well field (fig. 5). This site was selected because bench marks M1155 and P1155, near the extensometer site, have subsided more than 3 ft since 1961 and represent the largest amount of subsidence documented to date on the base (fig. 6).

At the extensometer site, an 8- x 12-foot metal building houses the extensometer, and two small, round 36-inch diameter buildings (fig. 9) house the

Water levels were measured at four wells located in two buildings near the Holly extensometer (fig. 9). One building houses one 2-inch diameter pipe placed to a 130 ft depth and two wells with 3-inch diameter pipes placed to depths of 470 and 645 ft. The second building houses a well that is 1,020 ft deep. Water

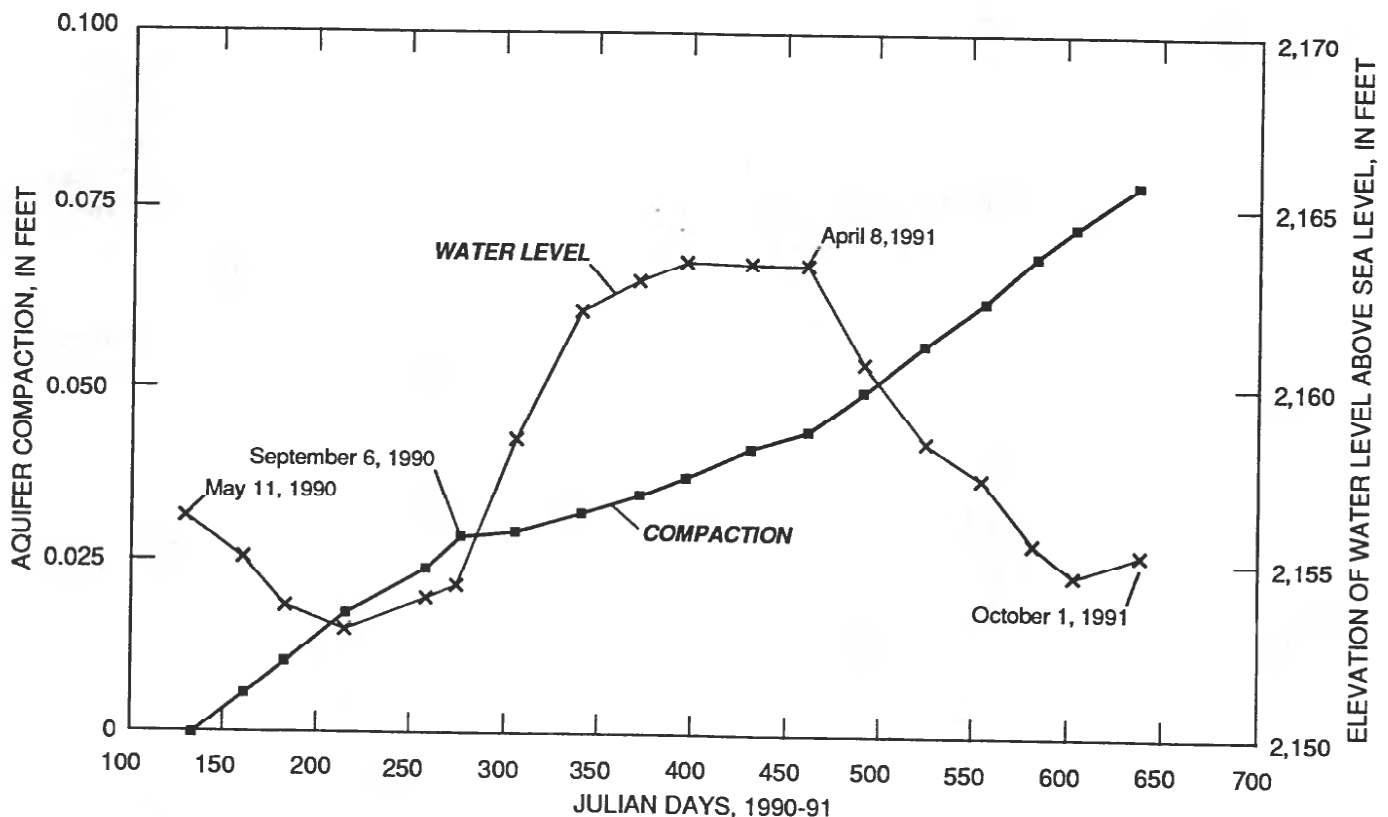
Figure 11. Aquifer compaction and water-level change between May 1990 and October 1991 at the Holly extensometer site.

Aquifer compaction at the Holly extensometer site between May 11, 1990, and October 1, 1991, was 0.078 ft (fig. 11). The rates of compaction shown on this figure, 1.88×10^{-4} ft/d prior to Julian day 259 (September 17, 1990), and 1.97×10^{-4} ft/d after Julian day 463 (April 12, 1991), indicate a continued rate of aquifer compaction that decreased only during the winter months of October 1990 through April 1991.
