# Testimony

Ericson John List , Ph.D., P.E.  
Consultant to Tejon Ranchcorp

# Antelope Valley

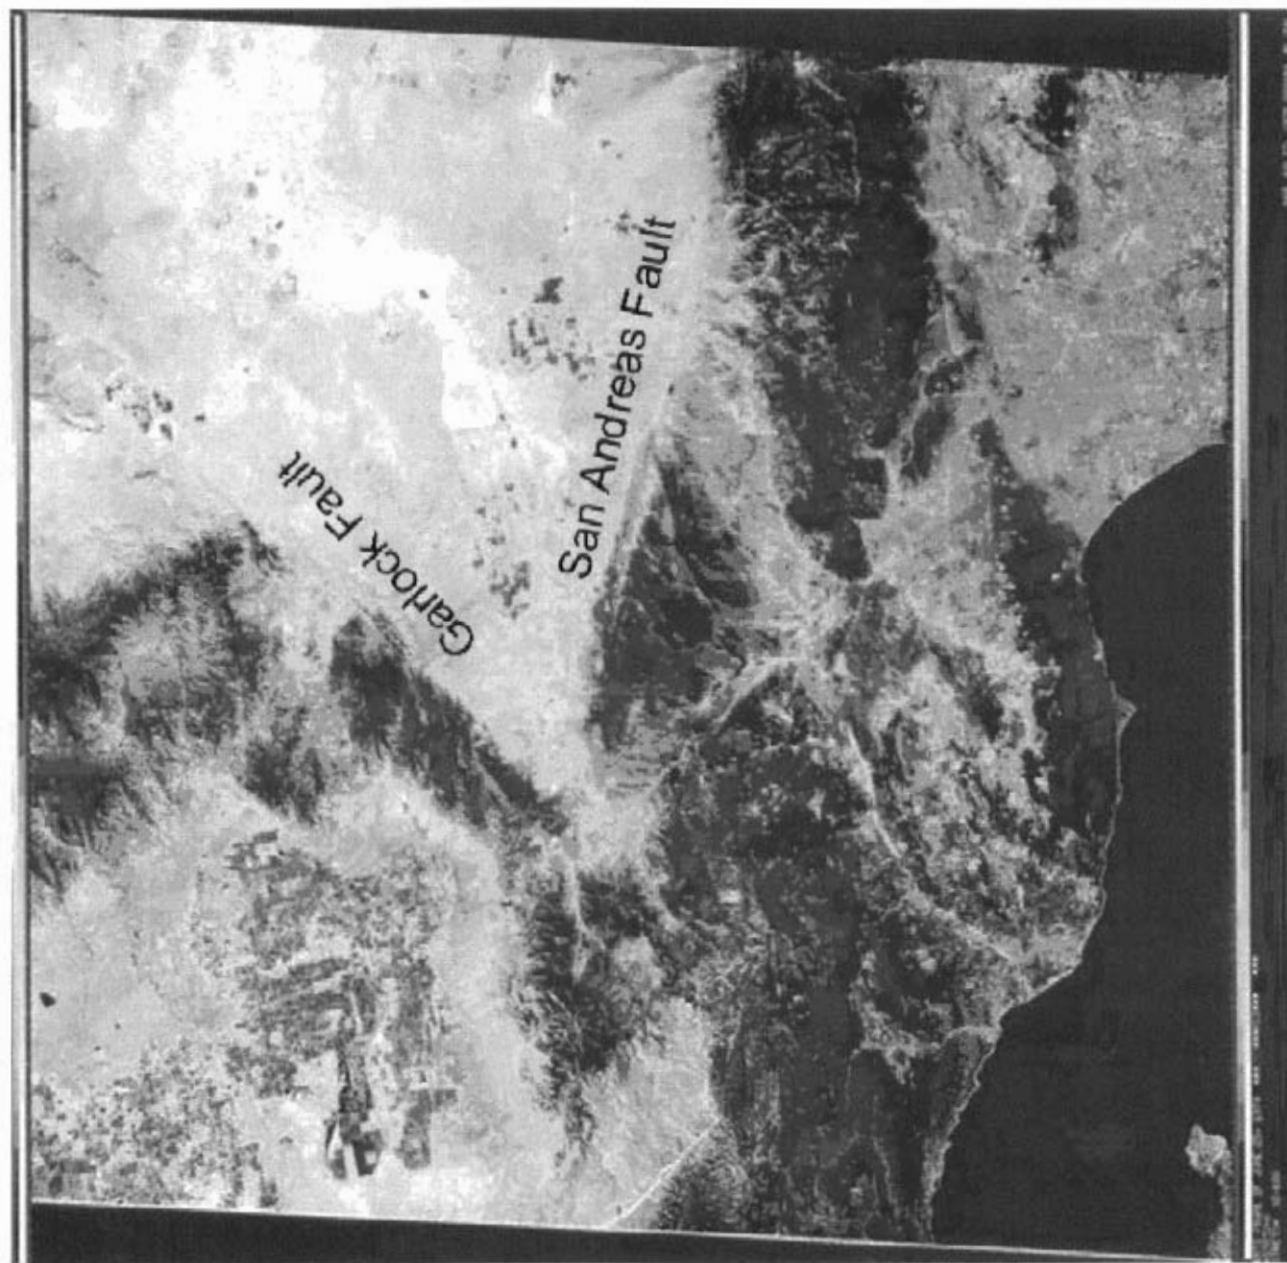
Figure 1 – Infra-red satellite view of the Antelope Valley (Source: NASA , ca. 1970).

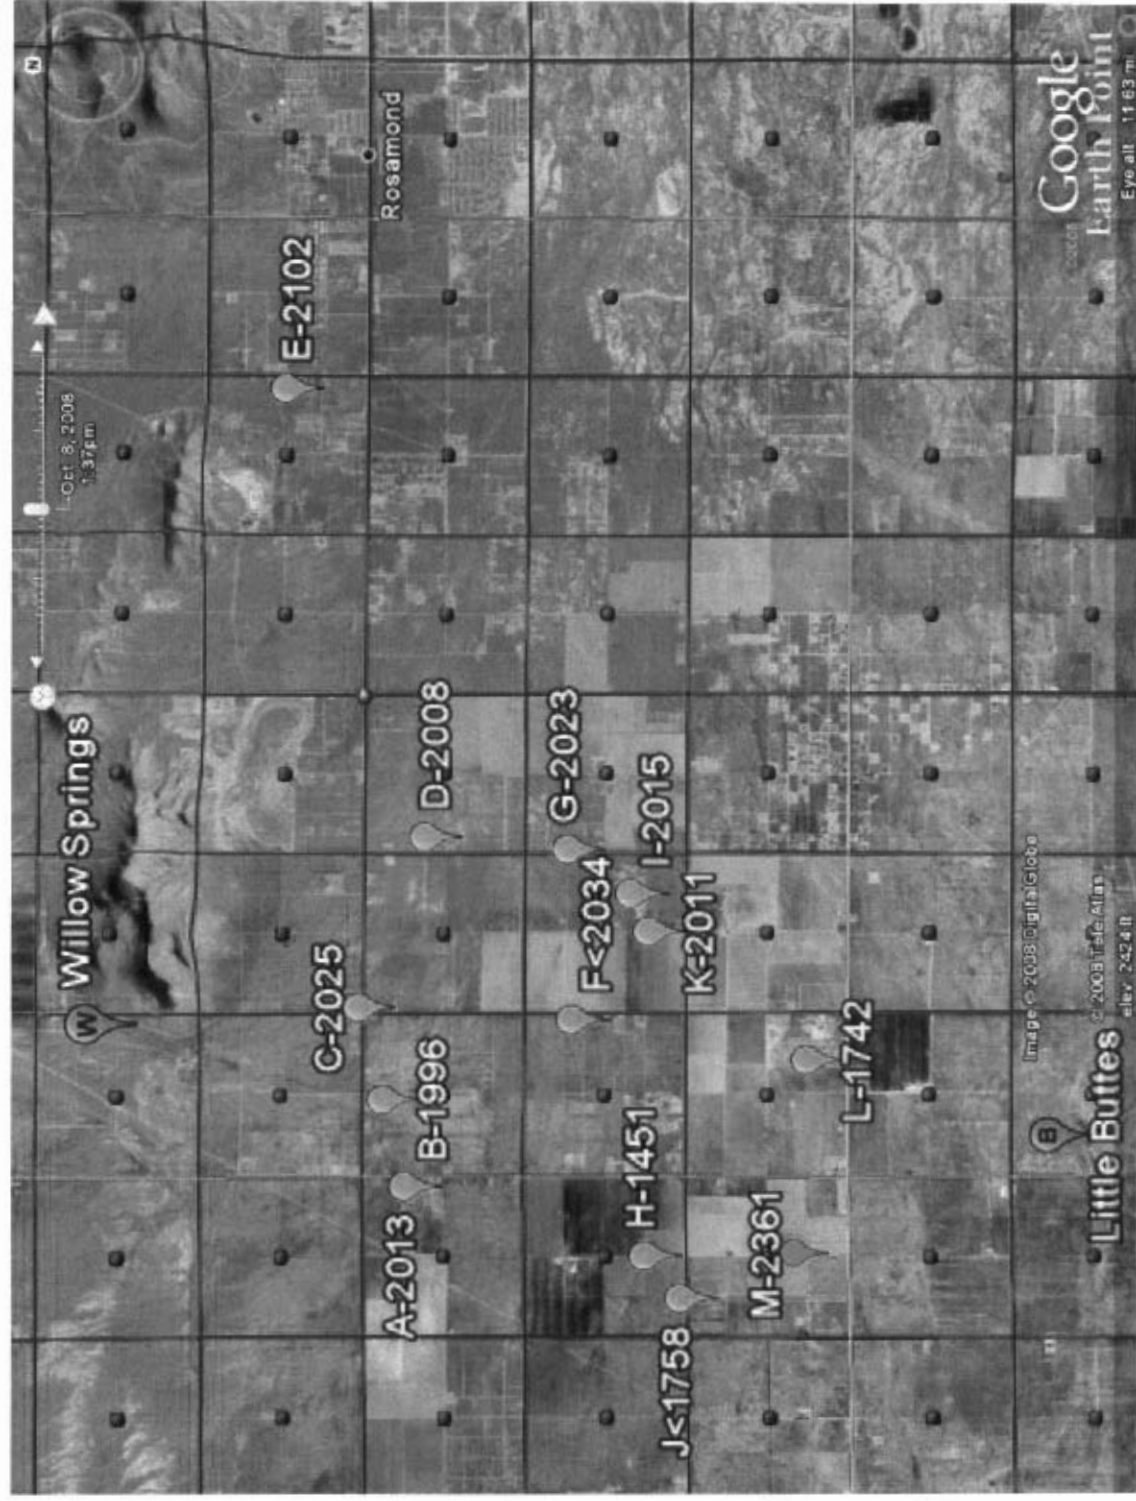
Figure 23 – Location of wells showing bedrock elevations

Figure 24 -  
Well log (M in Fig.  
23) identifying  
bedrock layer  
Ground  
Elevation  
2470

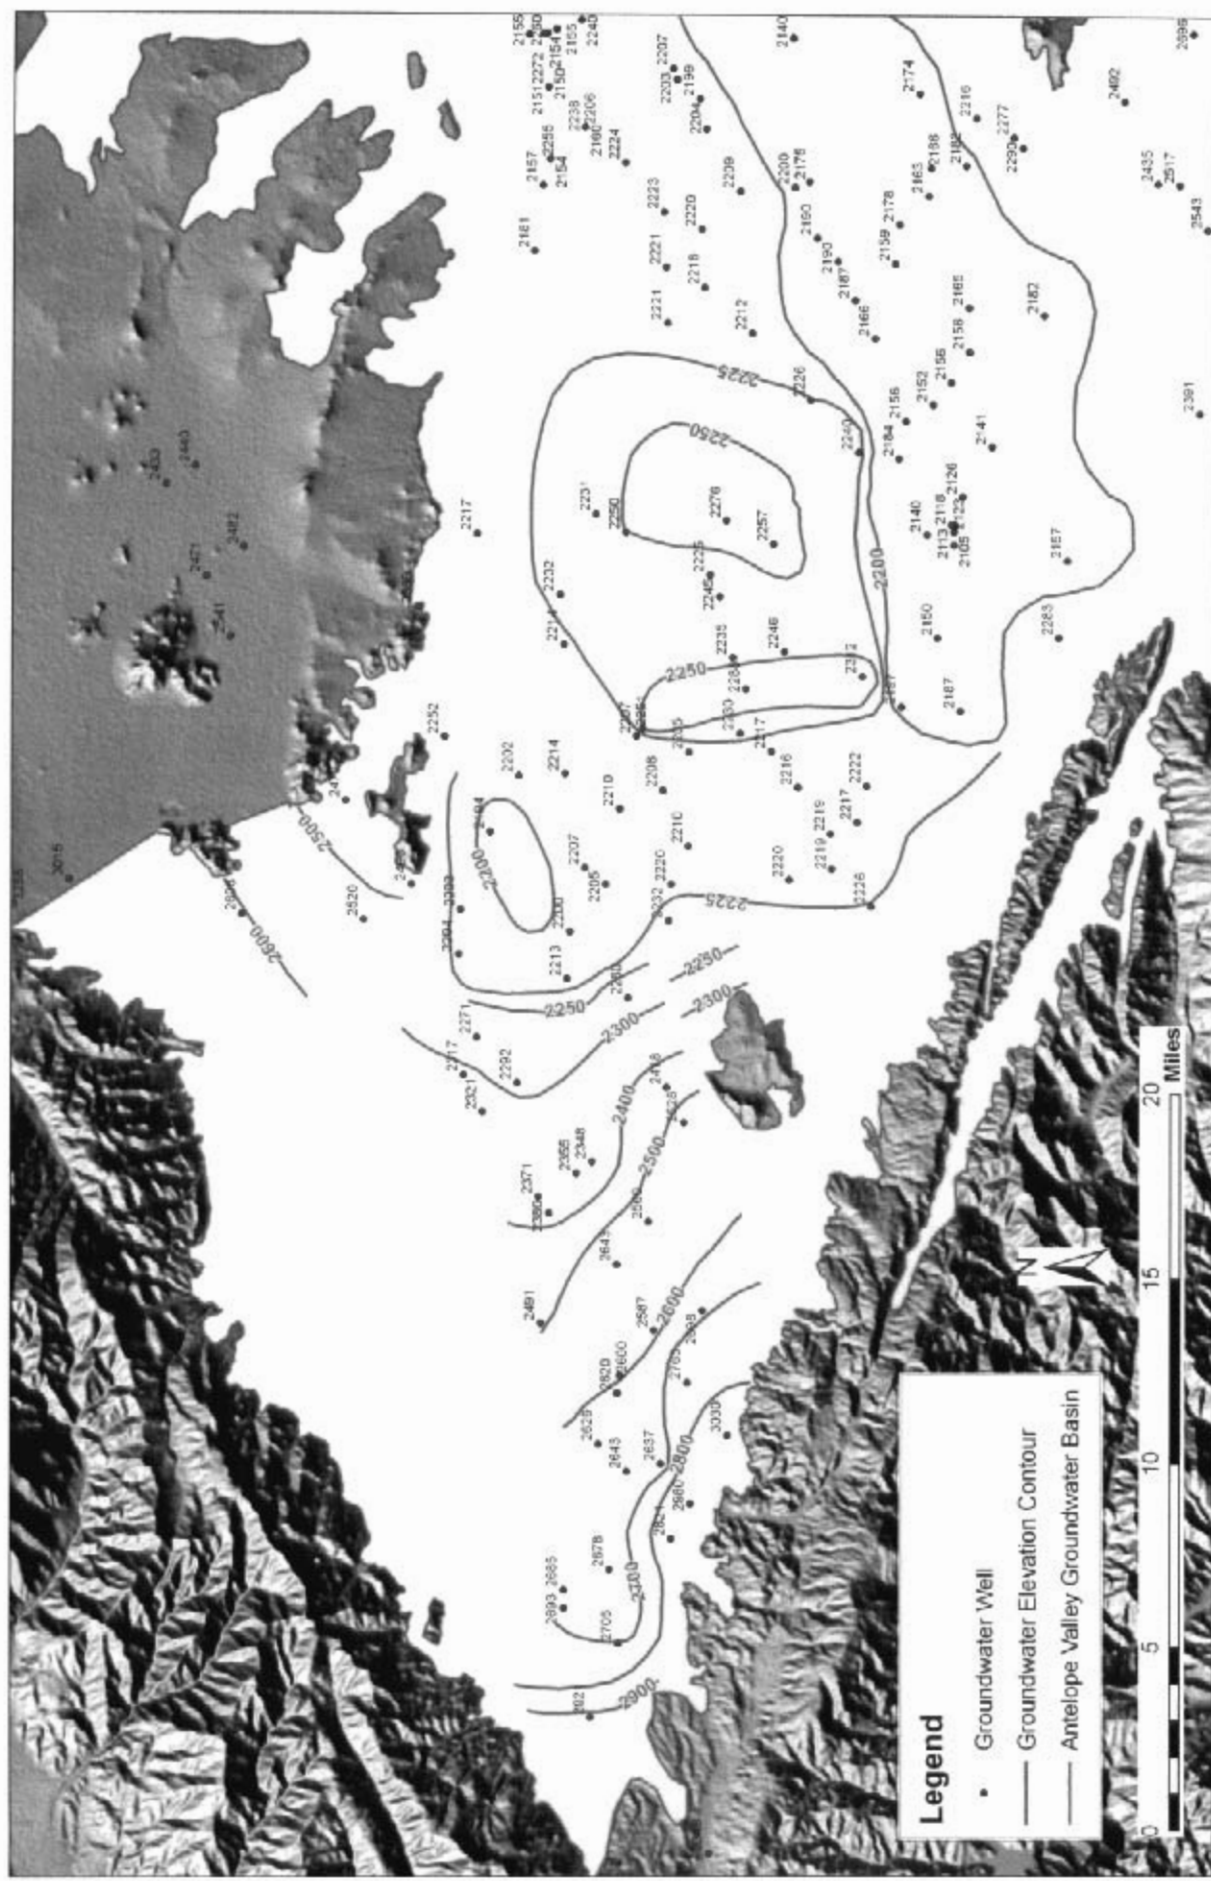
Figure 18 - Antelope Valley Groundwater Contours – 2005 Based on USGS Well Data

- Groundwater contour maps clearly show that little groundwater can have crossed the bedrock ridge in the last 40+ years
- The groundwater contours form a closed loop over the ridge and the area of the 2200 ft contour has shrunk significantly in 40 years
- A shrinking contour is indicative of a groundwater aquifer that is replenishing.
